Mount Morris Park Historic District Extension Designation Report

September 2015

Mount Morris Park Historic District Extension (LP-2751)
 Borough of Manhattan

Calendared April 14, 2015
 Public Hearing July 21, 2015
 Designated September 22, 2015

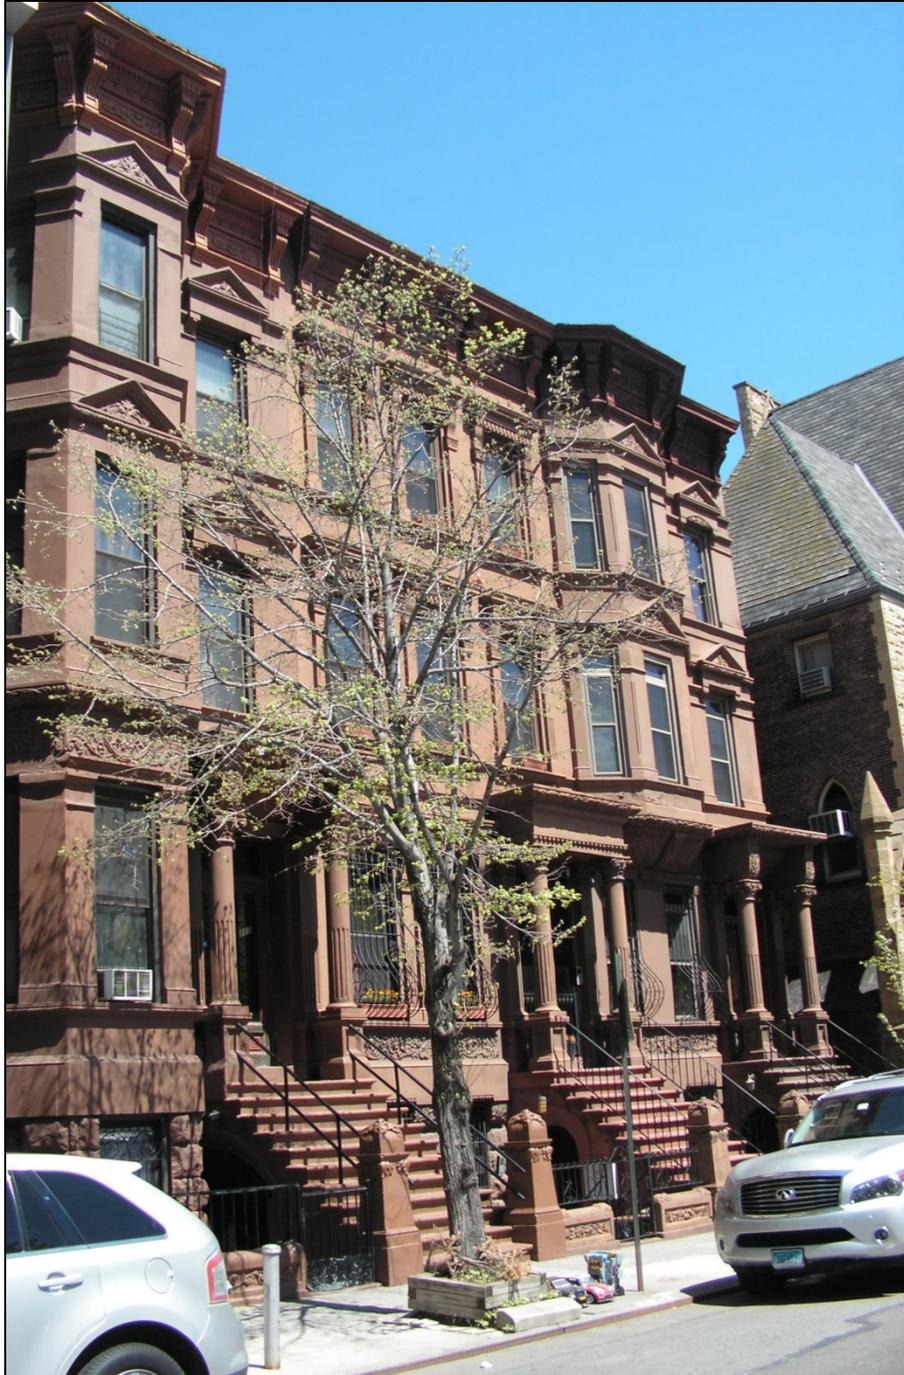
Figure 1
107 to 111 West 123rd Street
Cleverdon & Putzel, c.1899
Photo: Theresa C. Noonan, 2015

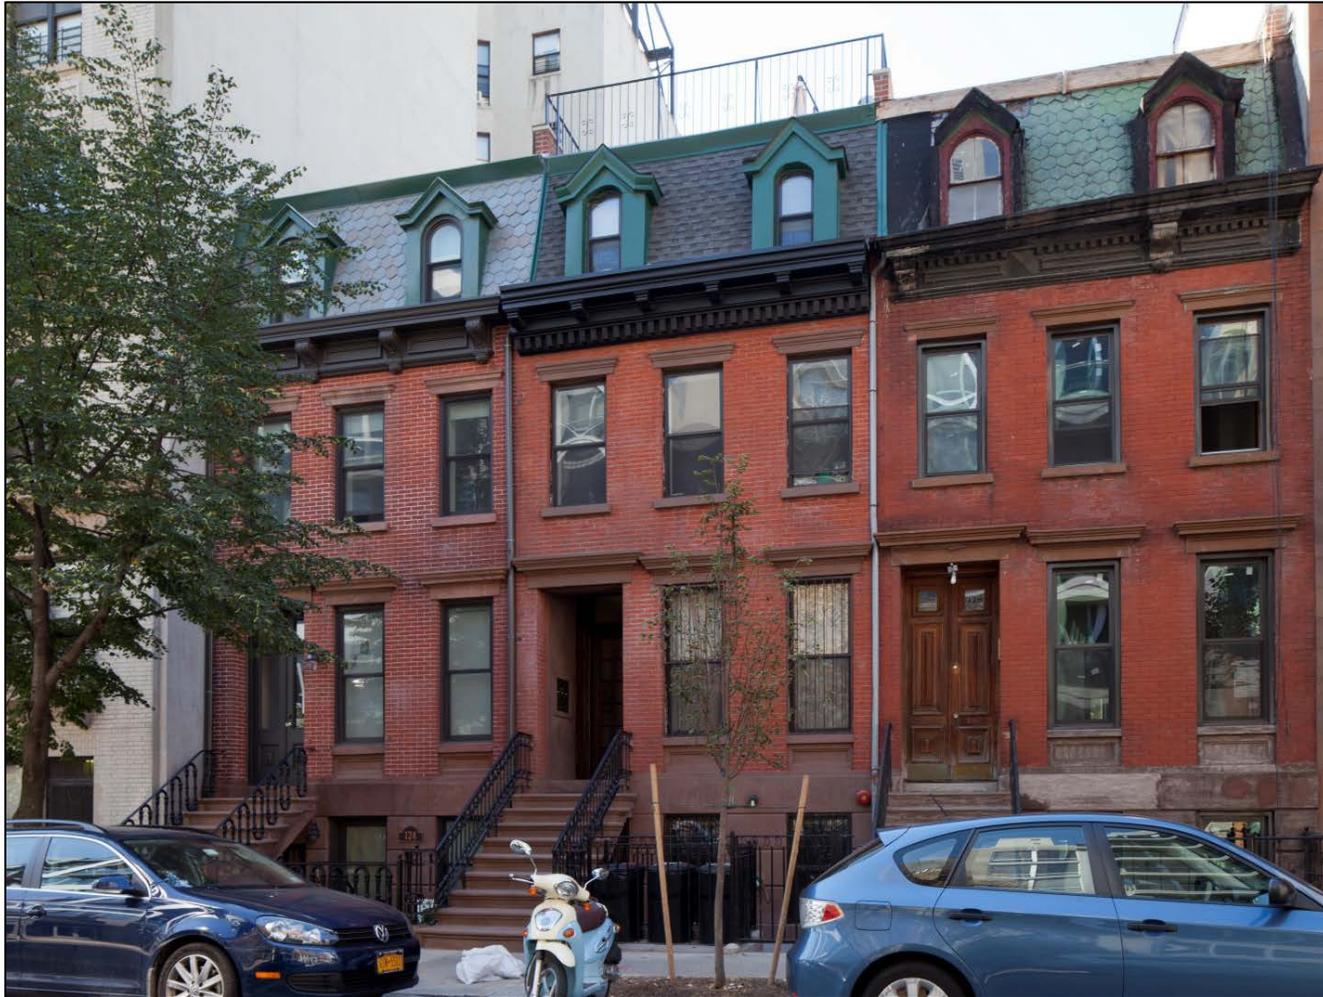
Figure 2
124 to 128 West 123rd Street
Abraham Slater, c. 1870
Photo: Christopher D. Brazee, 2015

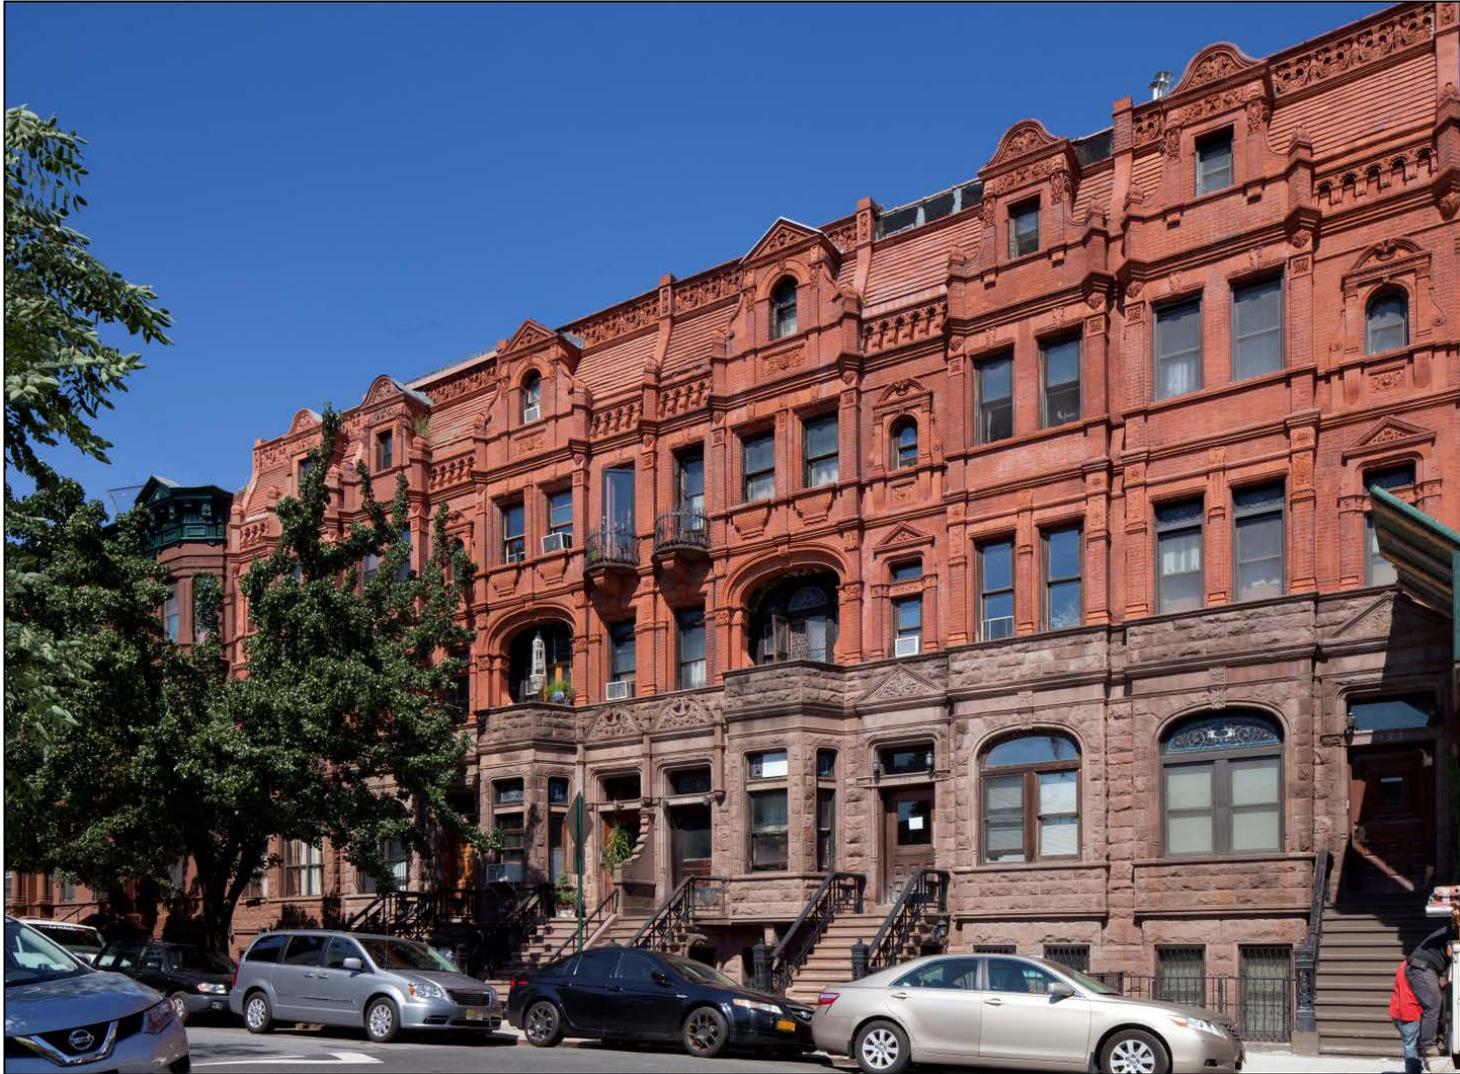
Figure 3
133 to 143 West 122nd Street
Francis H. Kimball, c.1885
Photo Christopher D. Brazee, 2015

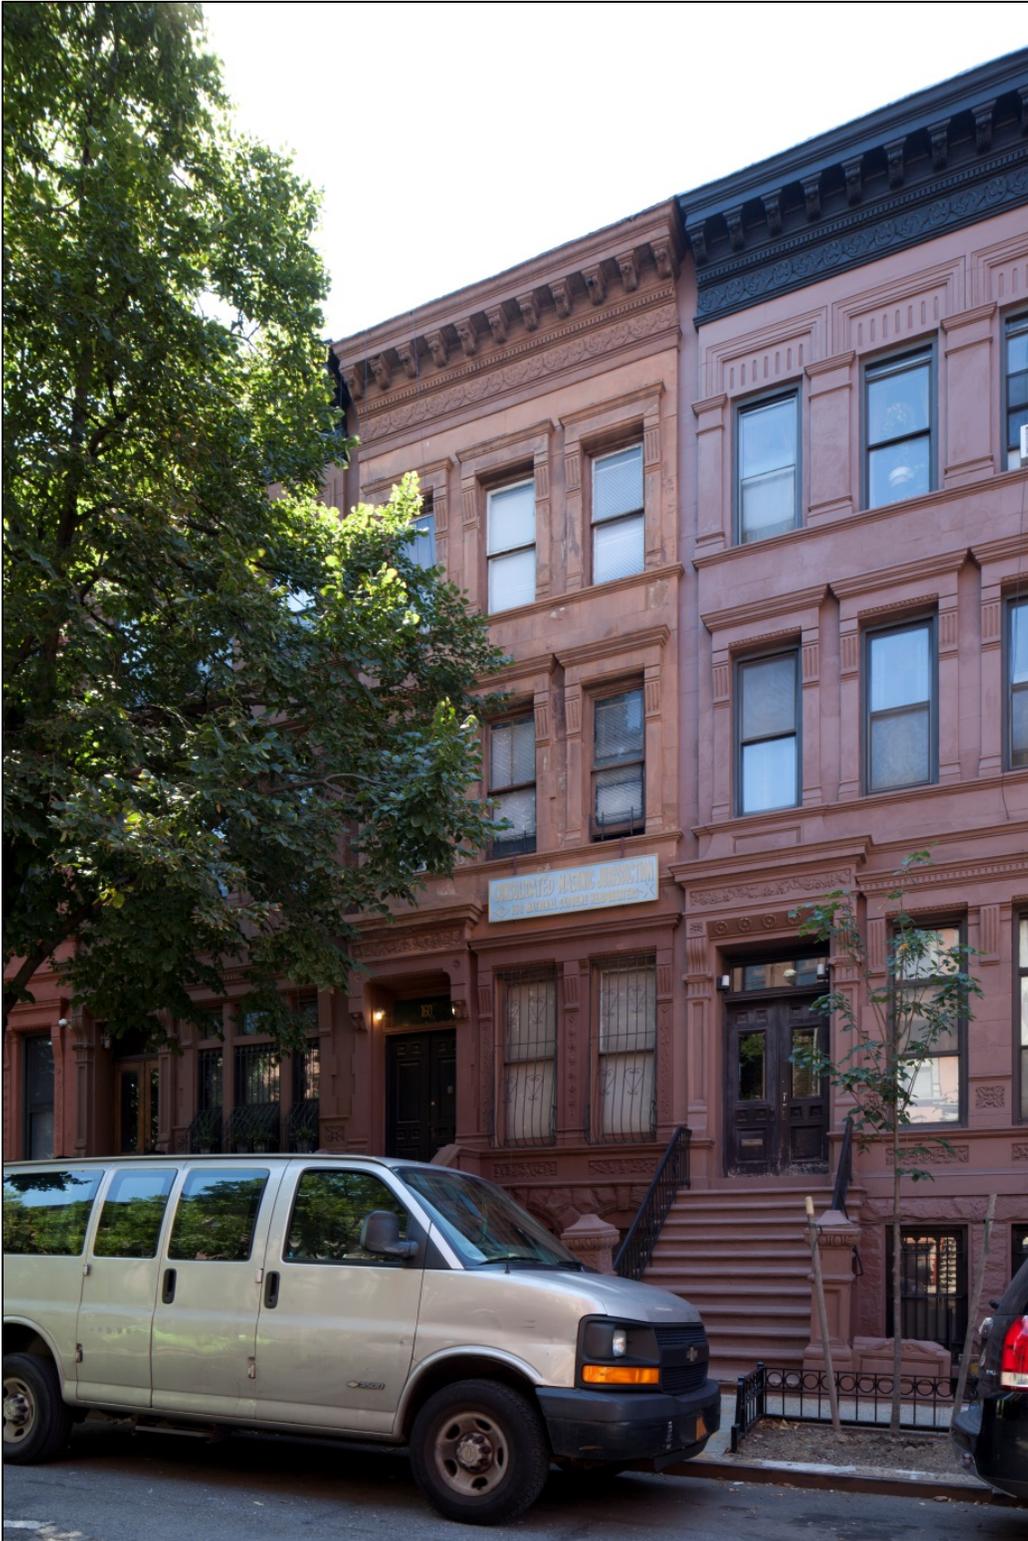
Figure 4
158 to 162 West 121st Street
Gilbert A. Schellenger, c.1888
Photo: Christopher D. Brazee, 2015

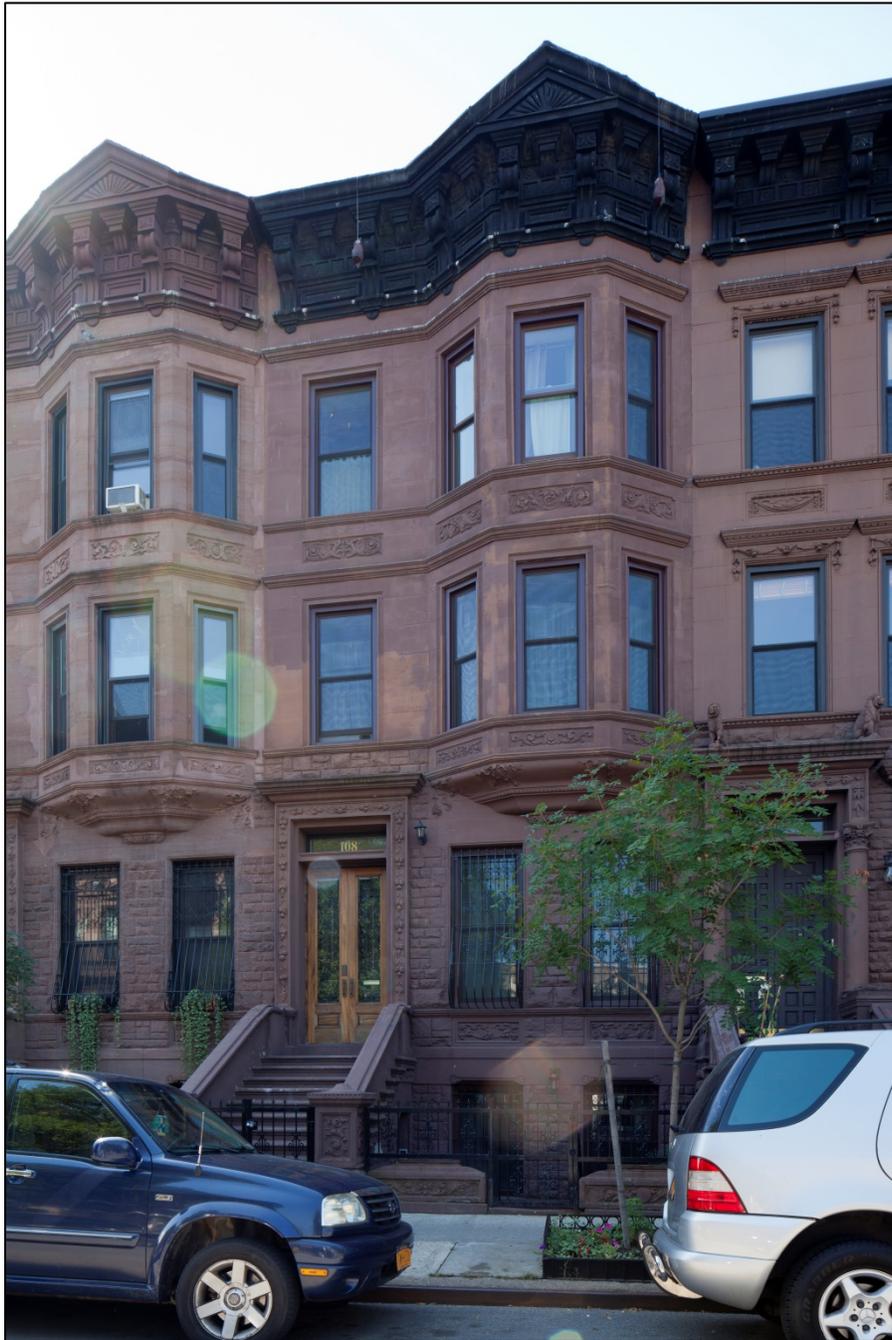
Figure 5
106 to 110 West 121st Street
Julius Franke, c.1890
Photo: Christopher D. Brazee, 2015

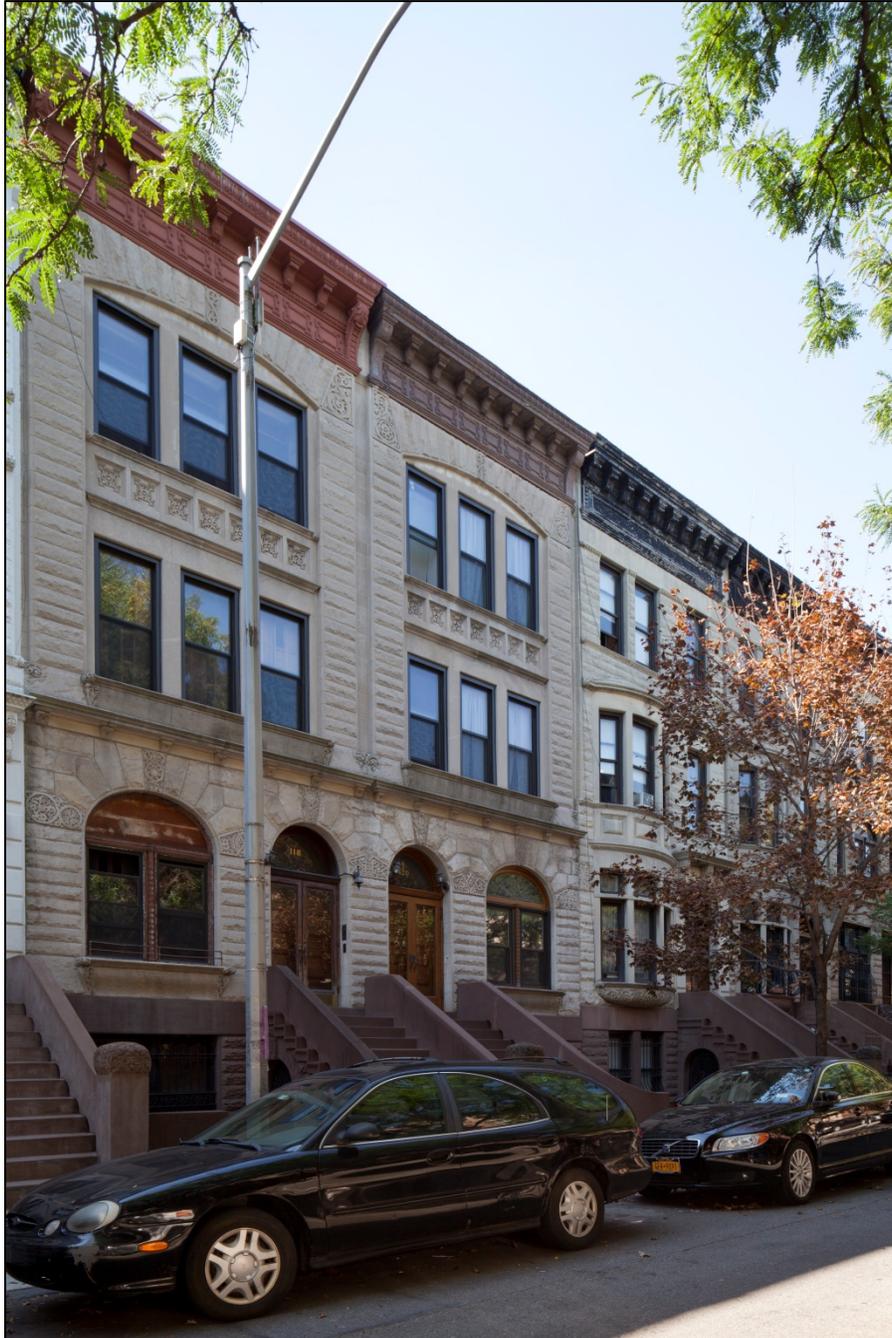
Figure 6
116 to 122 West 120th Street
Neville & Bagge, c.1893
Photo: Christopher D. Brazee, 2015

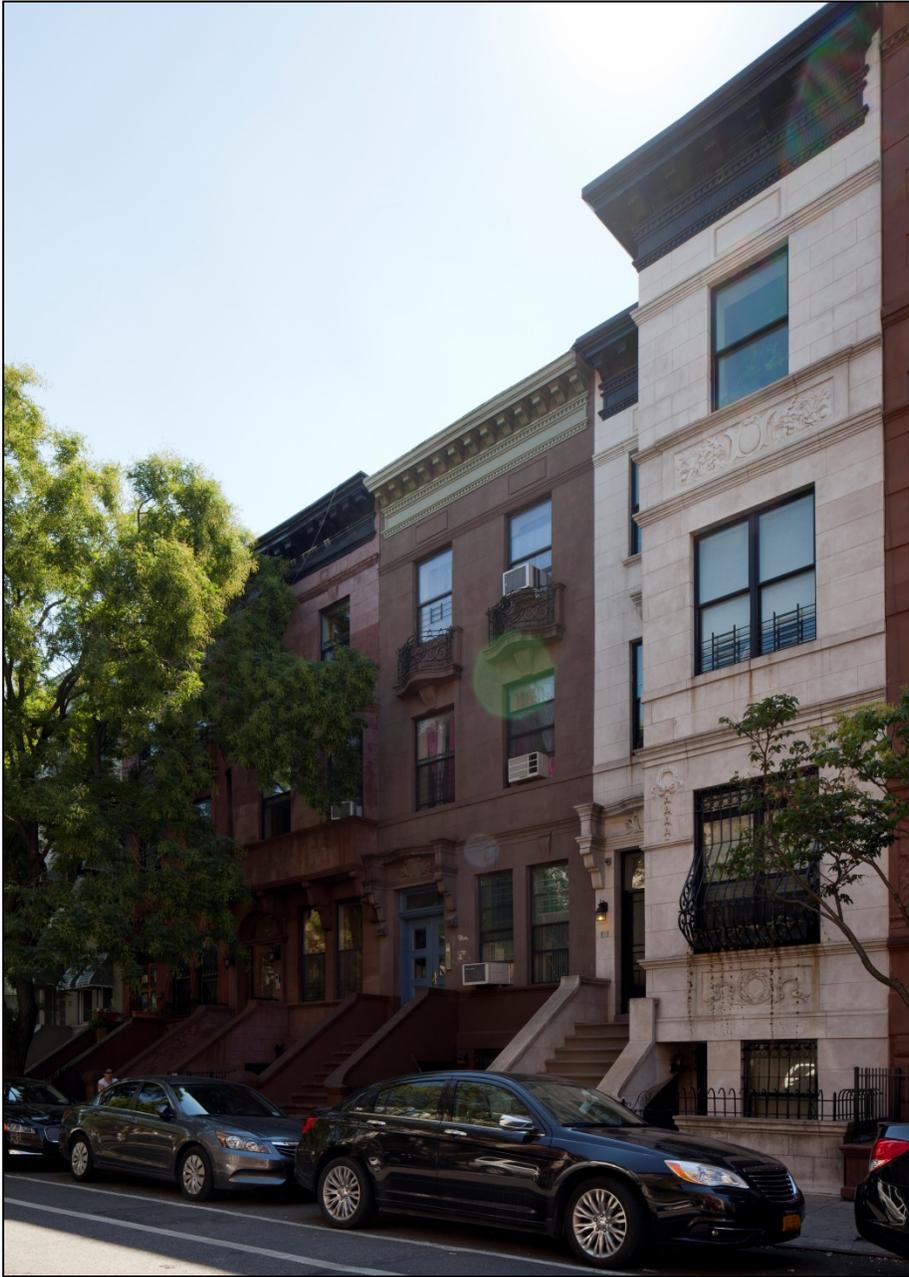
Figure 7
118 to 124 West 119th Street
Edward L. Angell, c.1901
Photo: Christopher D. Brazee, 2015

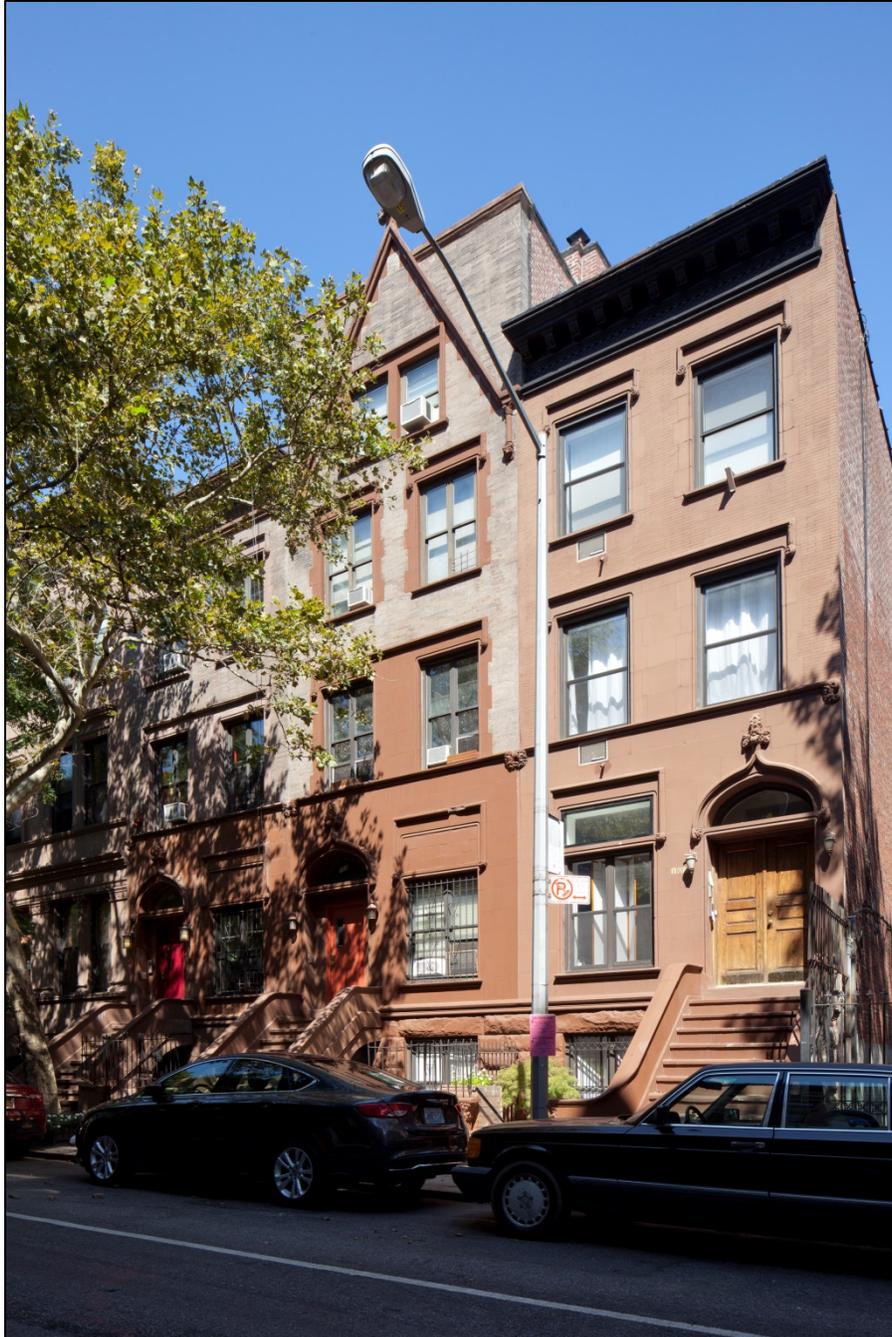
Figure 8
103 to 107 West 119th Street
Thomas M. Fanning, c.1892
Photo: Christopher D. Brazee, 2015

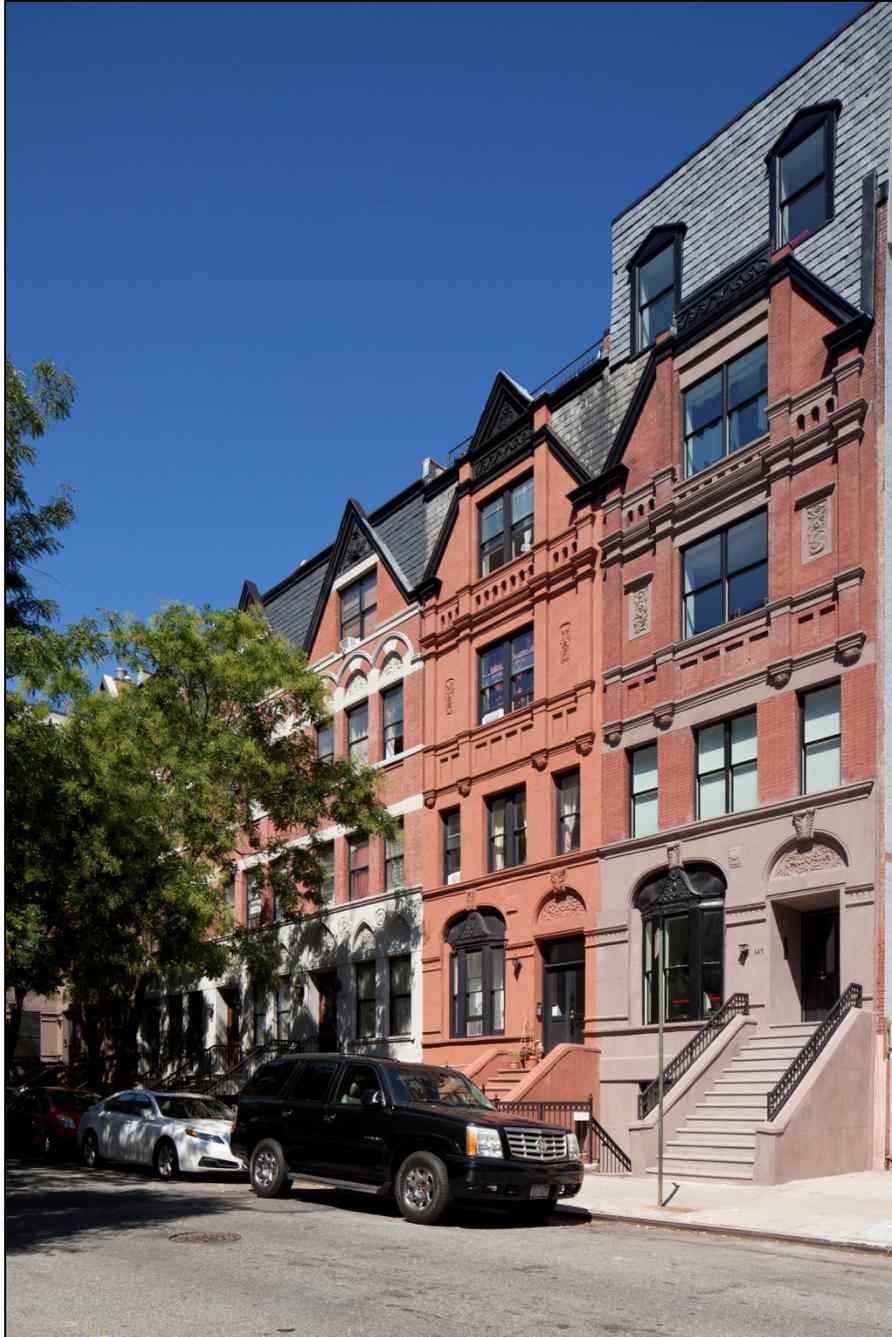
Figure 9
145 to 157 West 118th Street
Edward L. Angell, c.1887
Photo: Christopher D. Brazee, 2015

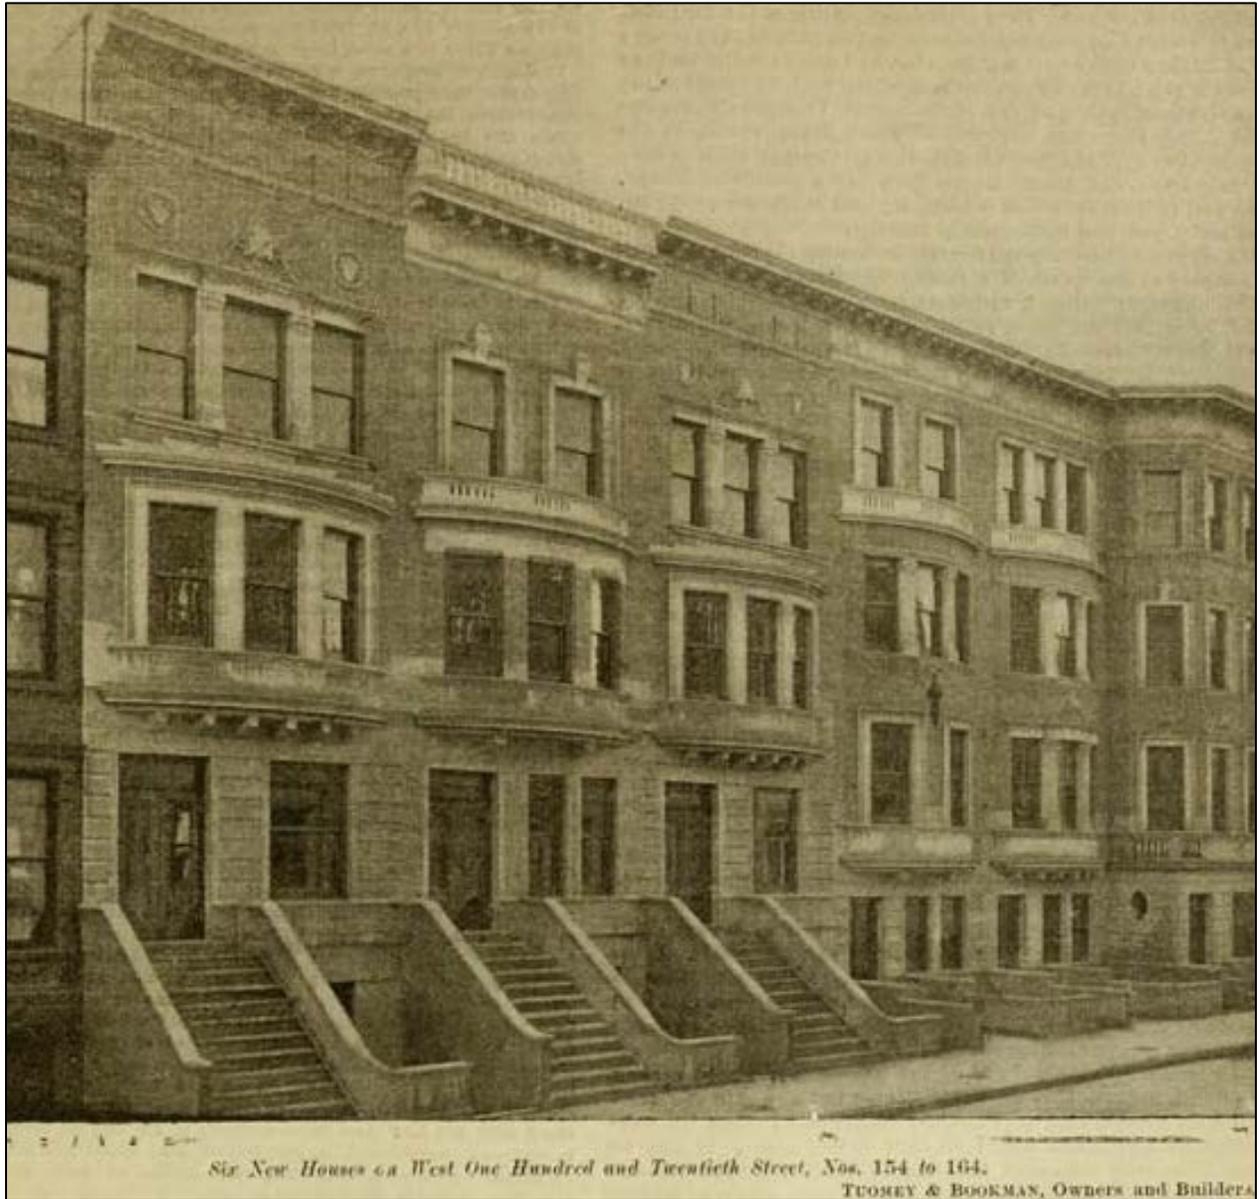
Figure 10
154 to 164 West 120th Street
Thom & Wilson, c.1895
Photo Source: Real Estate Record and Guide, February 15, 1896, page 259

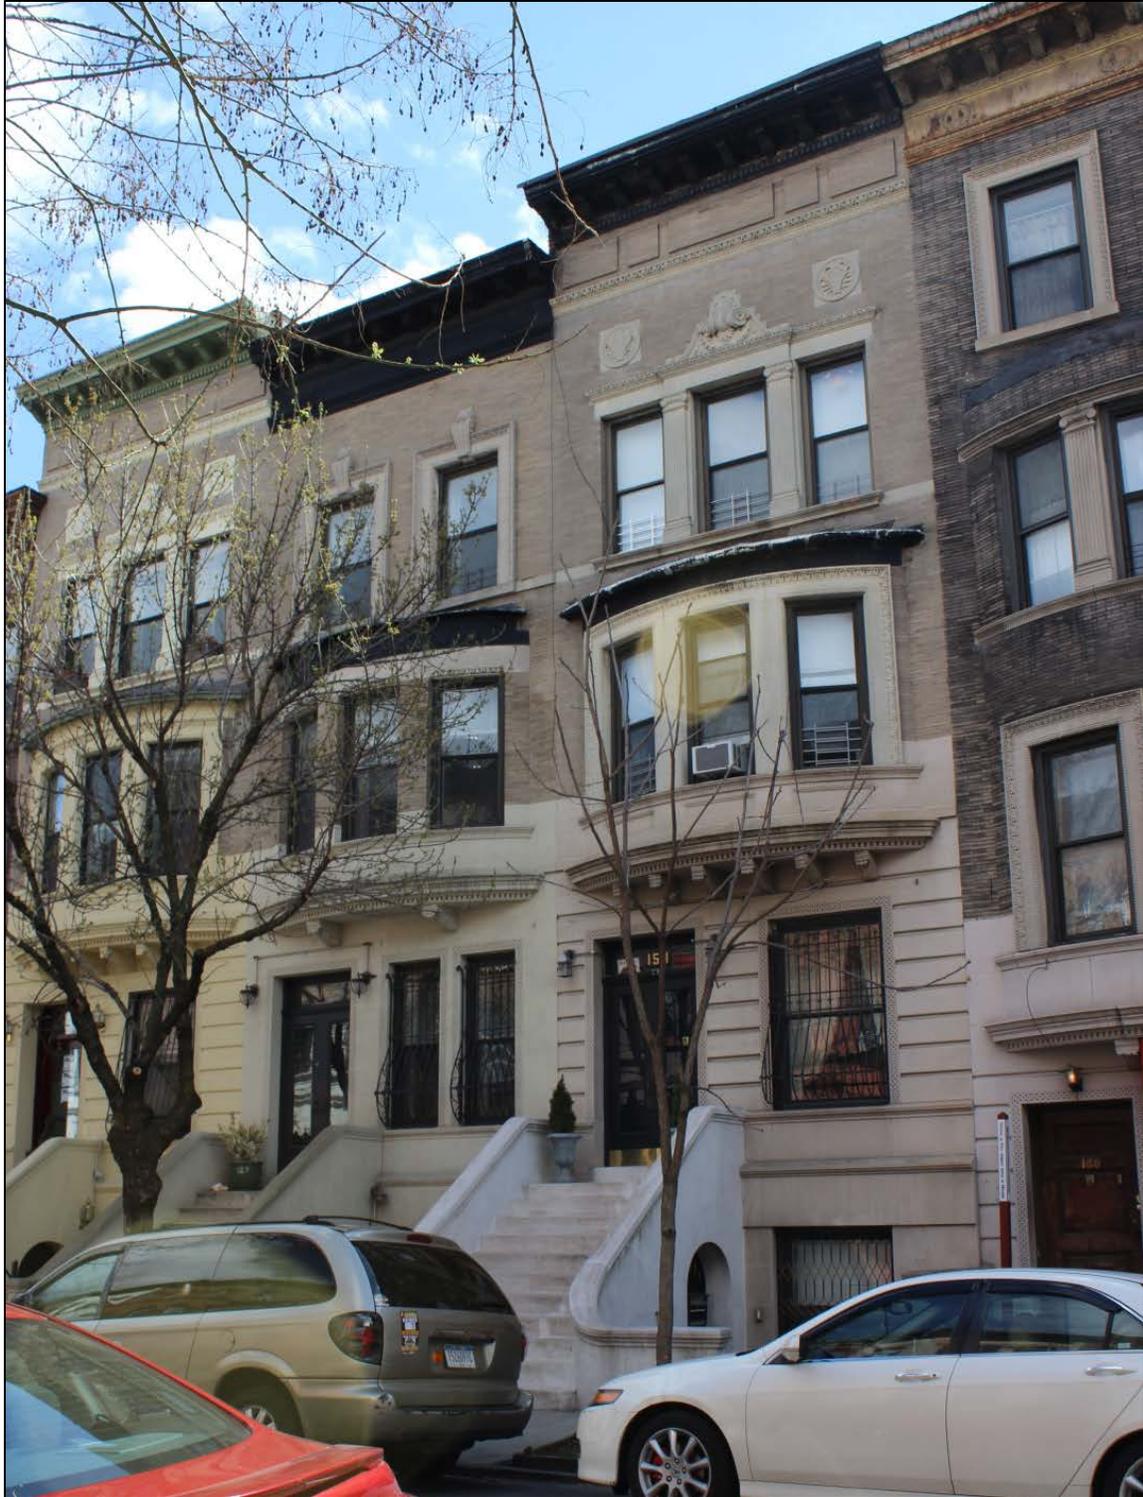
Figure 11
154 to 158 West 120th Street
Thom & Wilson, c.1895
Photo: Tara Harrison, 2015

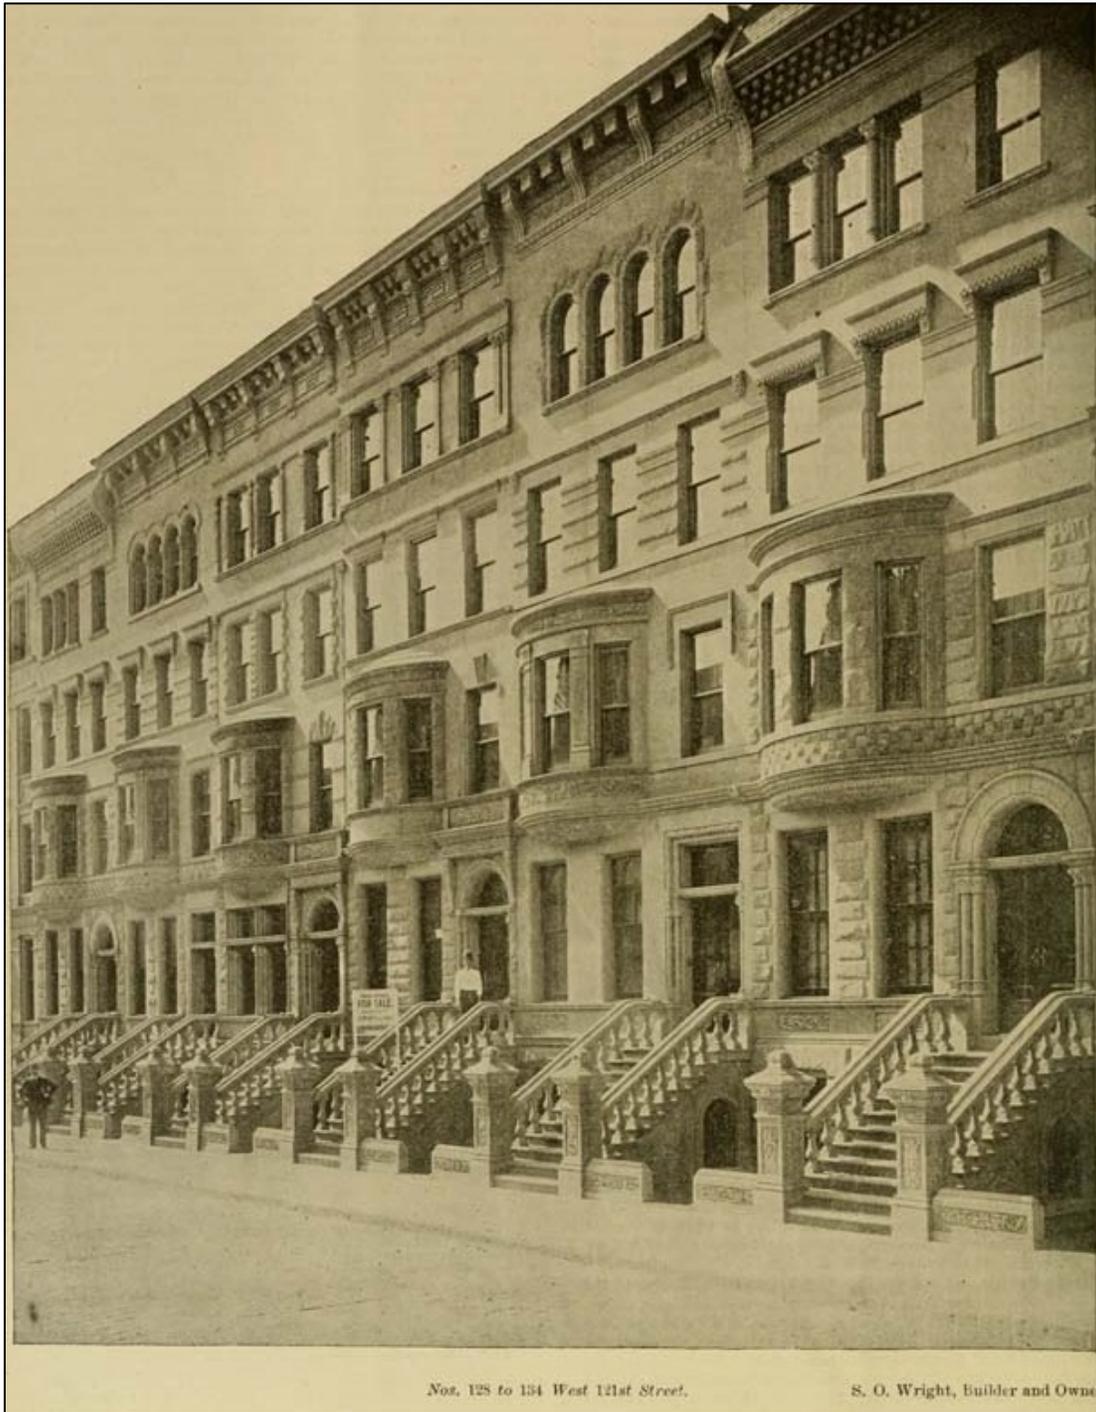
Figure 12
128 to 134 West 121st Street
Cleverdon & Putzel, c.1890

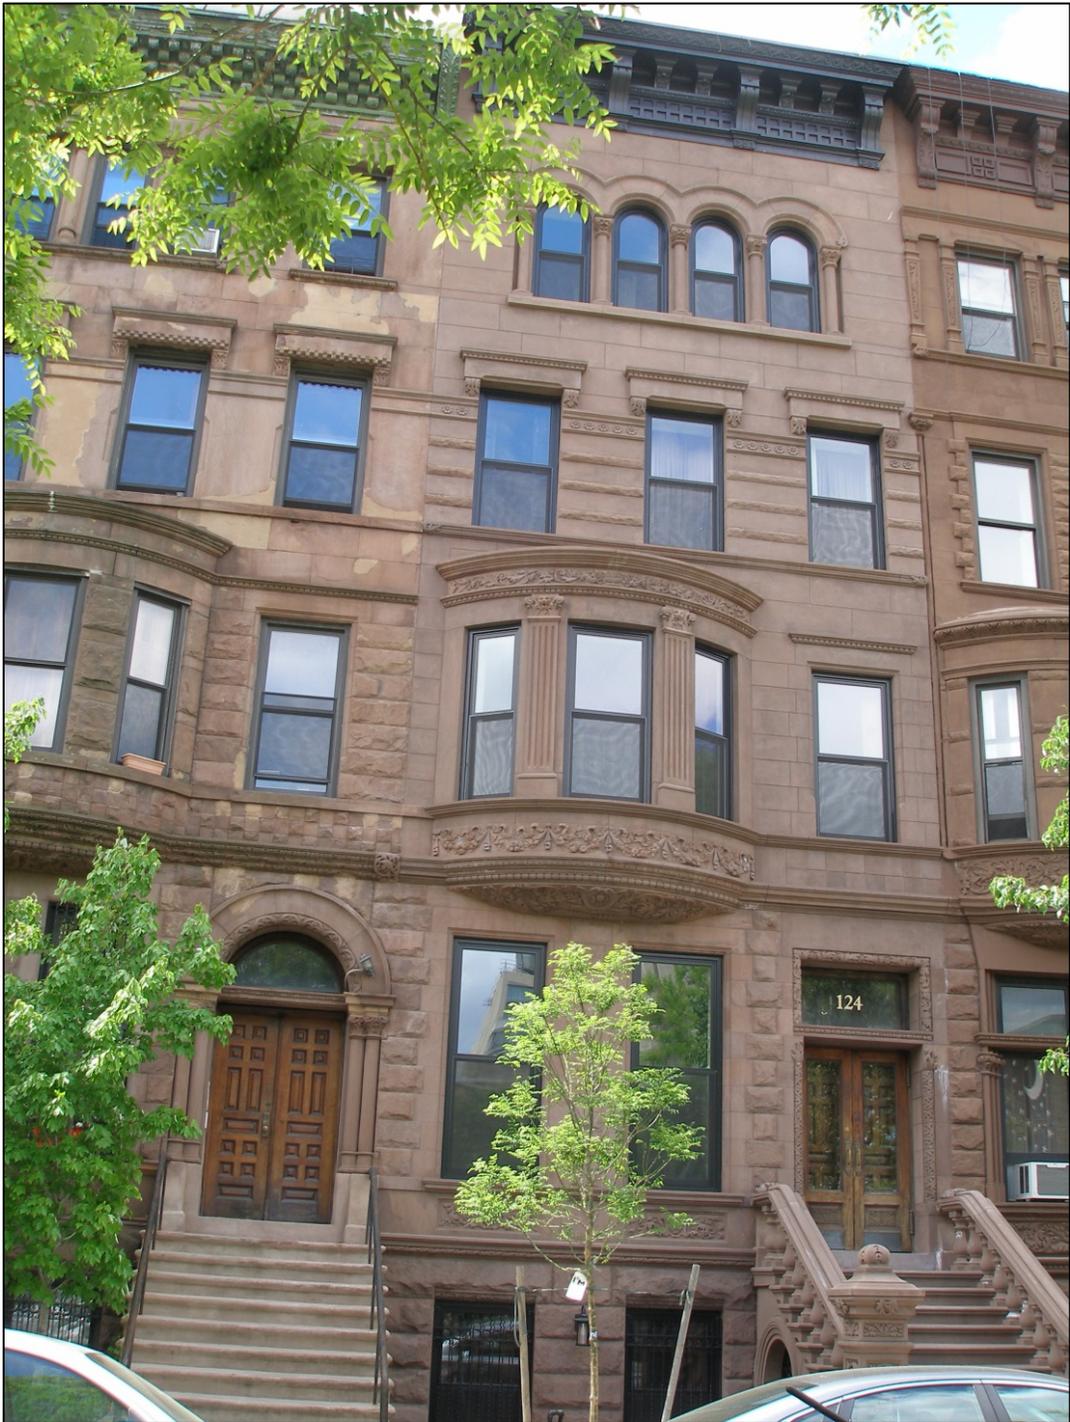
Figure 13
122 to 124 West 121st Street
Cleverdon & Putzel, c.1890
Photo: Donald G. Presa, 2015

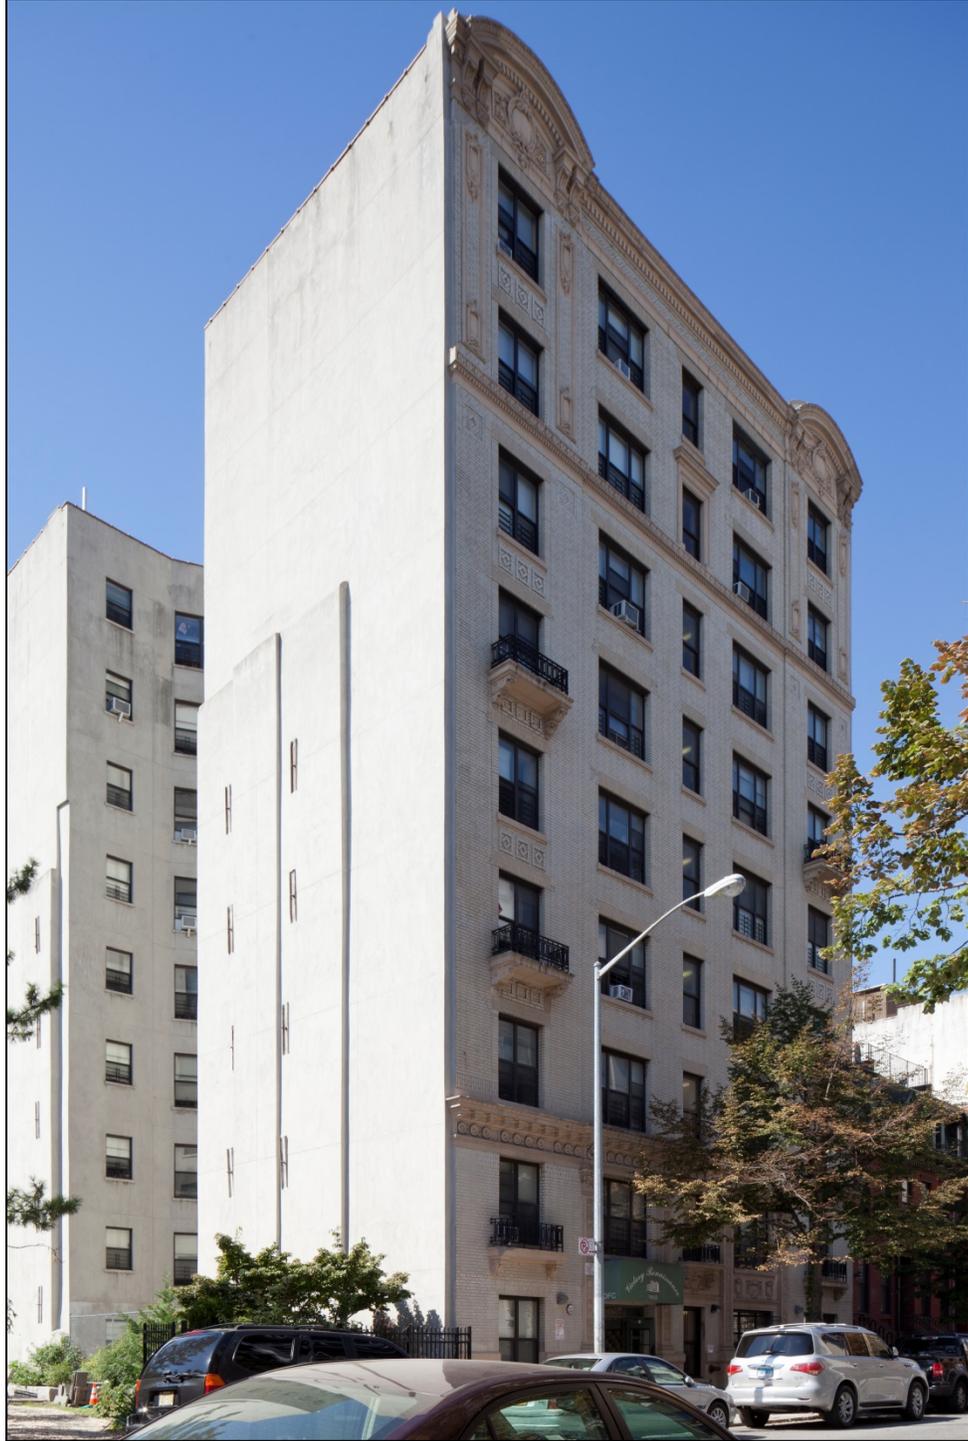
Figure 14
118 to 122 West 123rd Street
Neville & Bagge, c.1914
Photo: Christopher D. Brazee, 2015

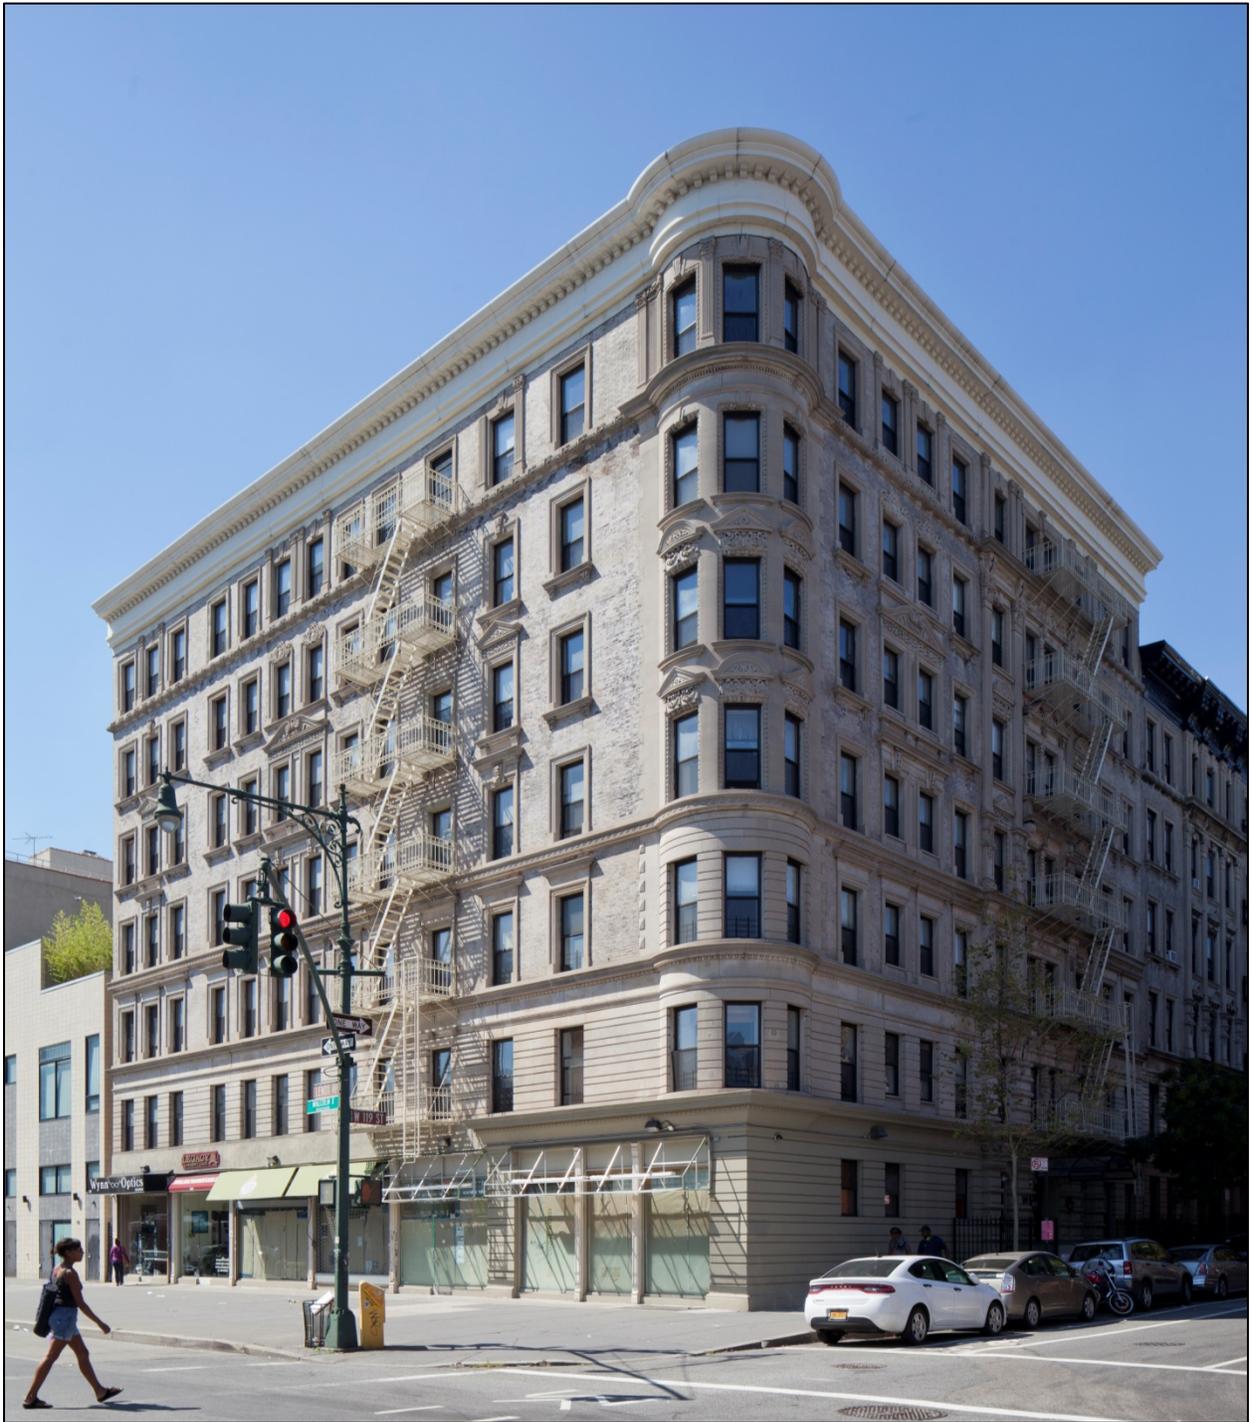
Figure 15
169 to 173 Lenox Avenue/Malcolm X Boulevard a.k.a. 100 West 119th Street
John Hauser, c.1900
Photo: Christopher D. Brazee, 2015

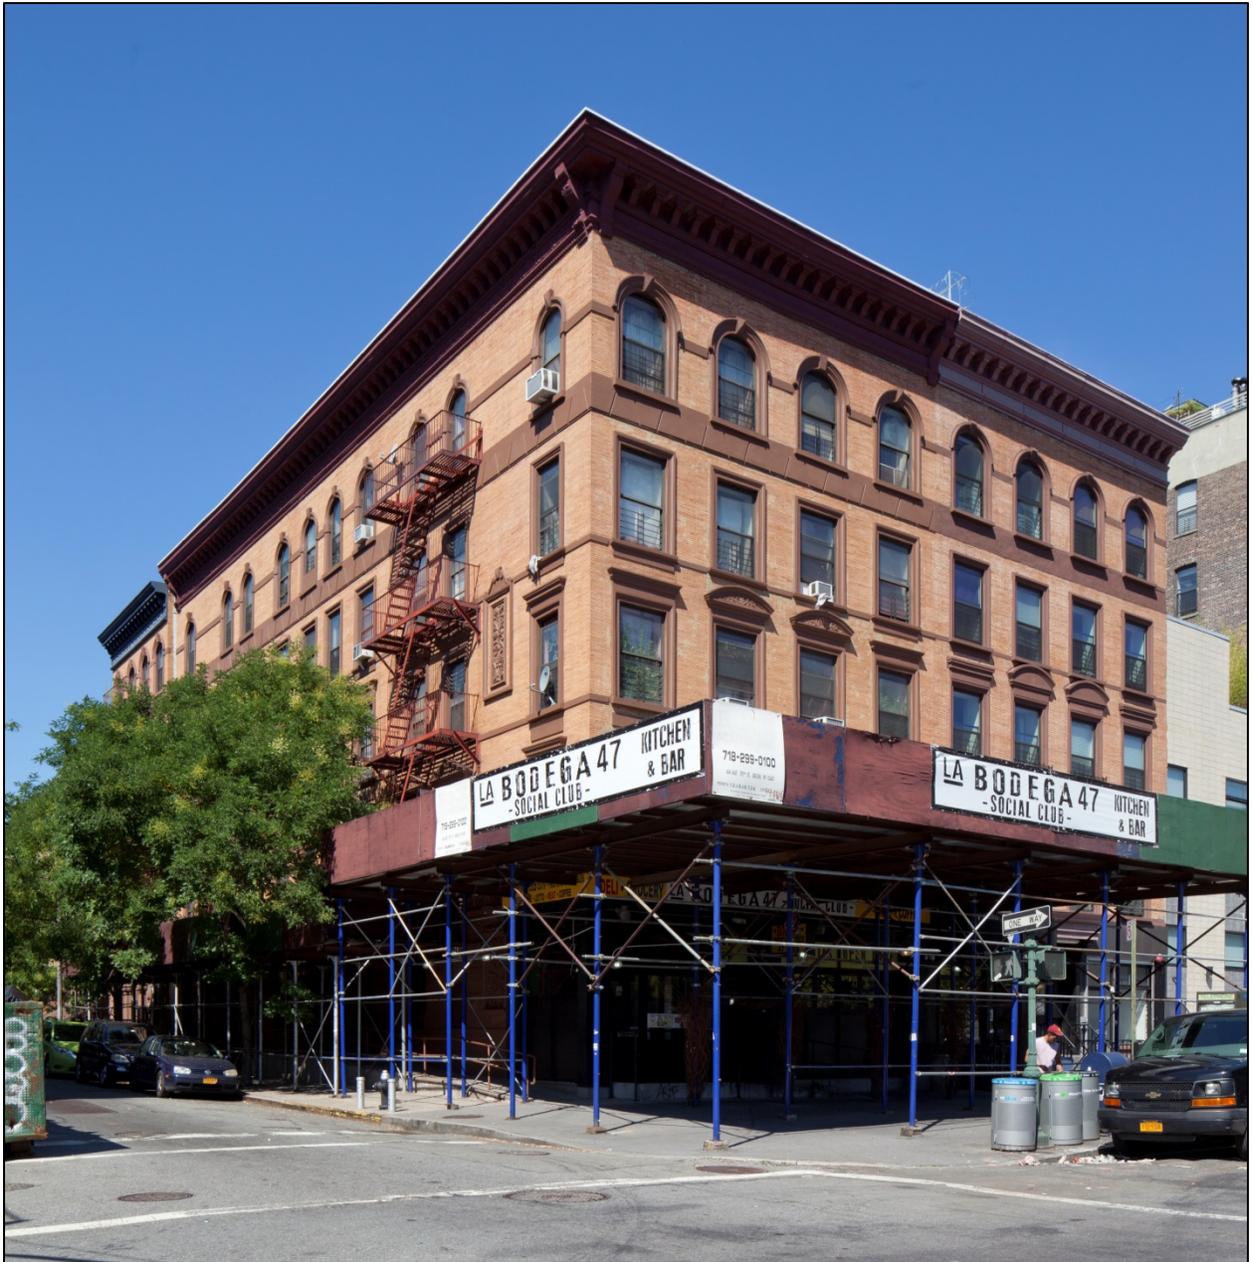
Figure 16
161 to 163 Lenox Avenue/Malcolm X Boulevard
John C. Burne, c.1895-96
Photo: Christopher D. Brazee, 2015
