Mount Morris Park Historic District Extension Designation Report

September 2015

Mount Morris Park Historic District Extension (LP-2751)
 Borough of Manhattan

Calendared April 14, 2015
 Public Hearing July 21, 2015
 Designated September 22, 2015

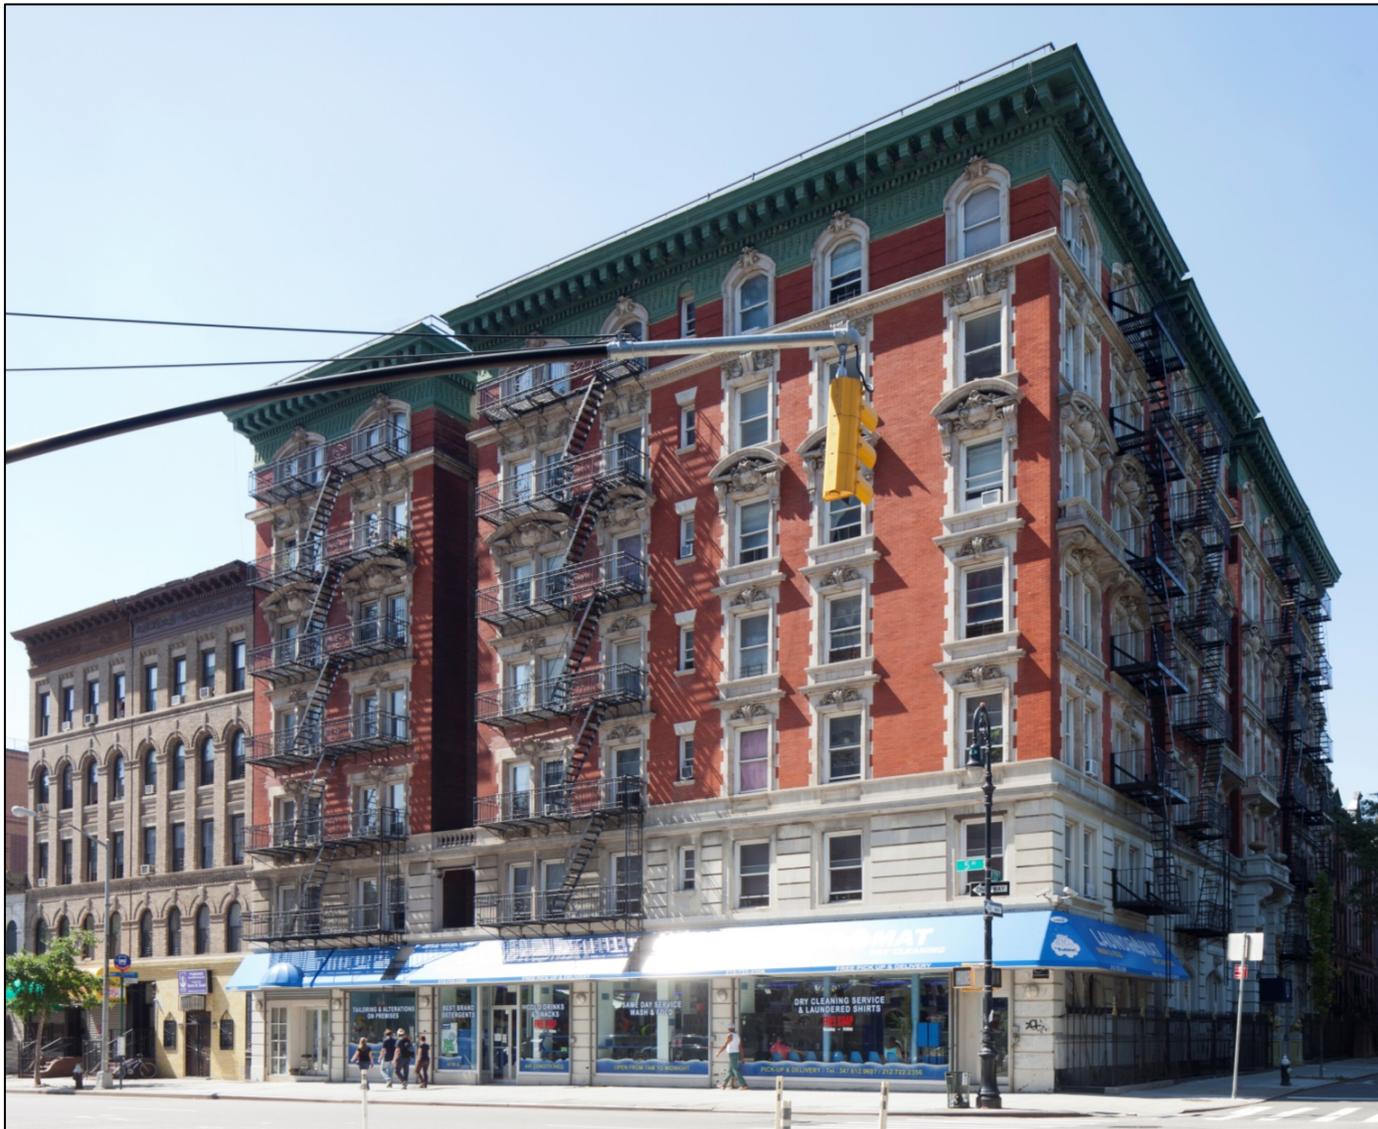
Figure 17
2 West 120th Street aka 1490-1500 Fifth Avenue
George F. Pelham, c.1900
Photo: Christopher D. Brazee, 2015
